Buttahatchie River River Bank Stabilization Project

Brad Maurer, The Nature Conservancy
Andrew Peck, The Nature Conservancy

The presentation will describe the individual BMPs, their installation process, and the resulting improvements to the river bank.

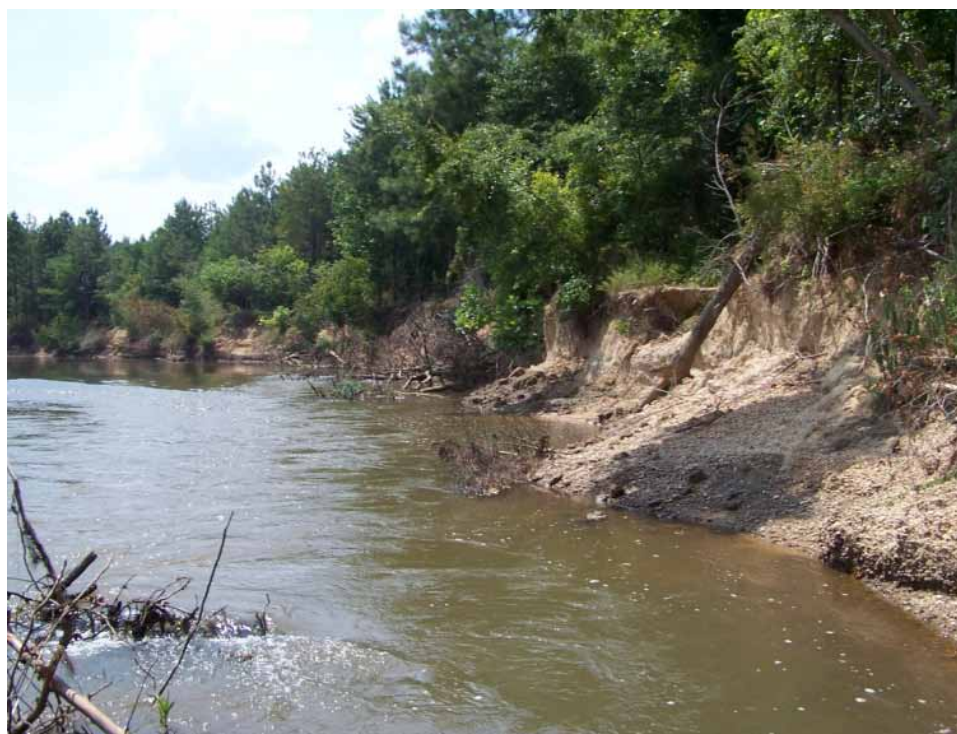
Figure 2. Pre-construction conditions at the Lowndes County site.

The Lowndes County project site is situated on the outside of a meander bend, and in its original condition the river was eroding in a westerly direction into the property (left descending bank). The site exhibited steep, rapidly eroding banks, mass wasting, and numerous trees that had recently washed into the river or were on the verge of being undercut. A review of aerial photographs showed that the river had moved laterally up to 250 feet over the last 30 to 40 years, with a large gravel bar developing on the opposite bank.

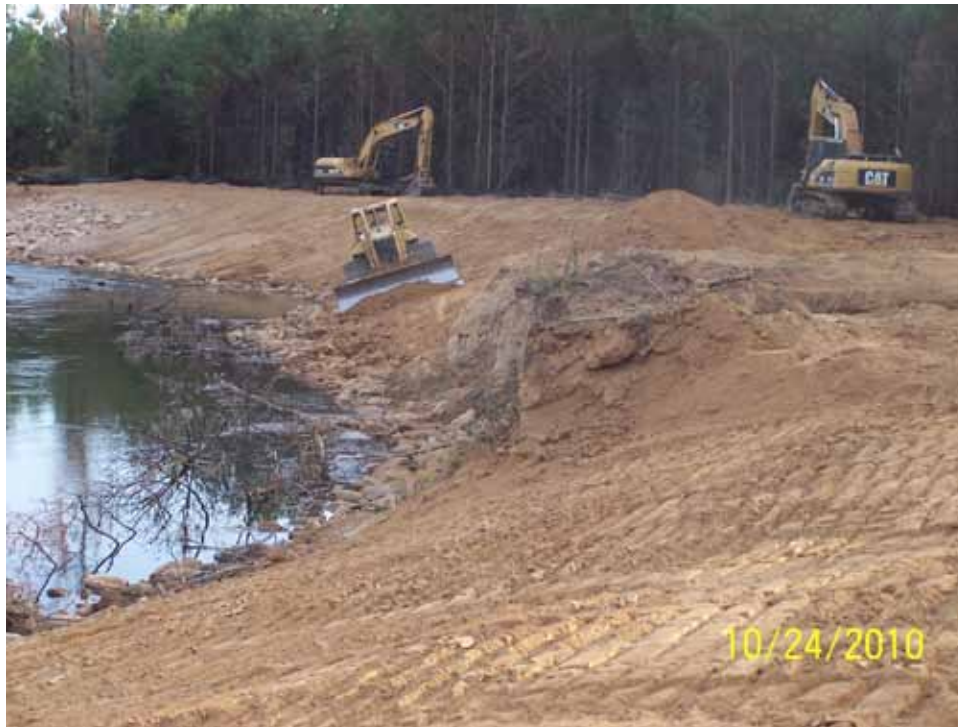
Figure 4. Regrading of unstable river bank.

Steep eroding river banks were excavated to a more stable slope of approximately 3:1. Without this project, virtually all of the soil that was removed would eventually have eroded into the river (Fig. 4).

Bank regrading is appropriate in areas of rapid erosion where the banks are too steep to stabilize in their existing configuration or unable to support vegetation that will create stability.

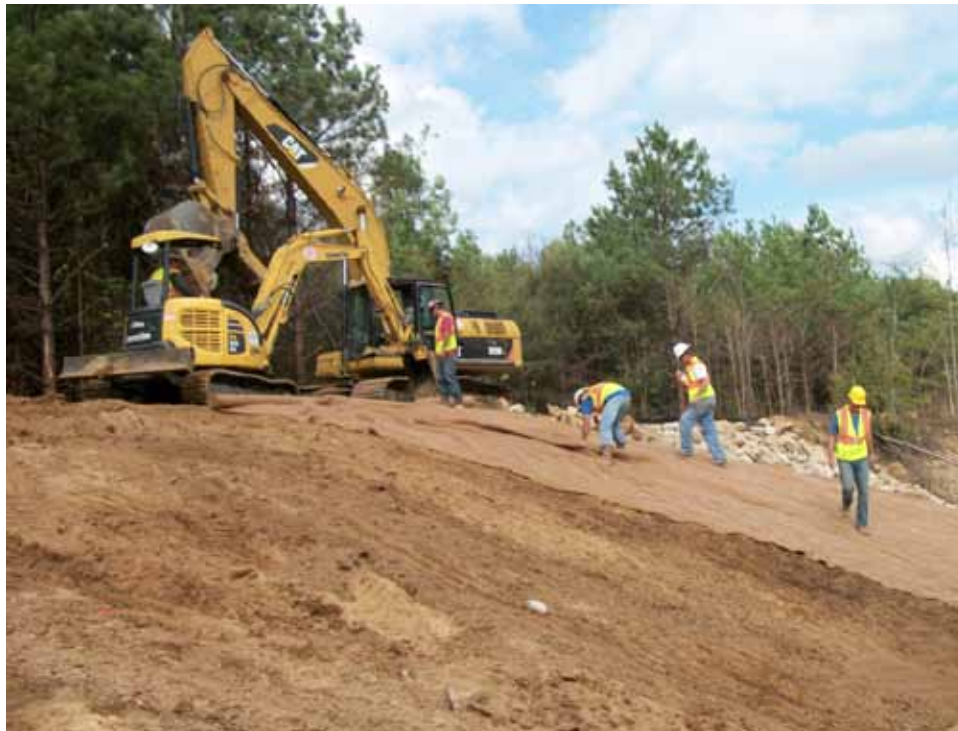
Figure 5. Installation of erosion control blanket.

The biodegradable erosion control blankets are made of coconut shell fibers and netting. The blanket holds the soil in place until vegetation becomes established, and will eventually degrade and disappear. It was installed in all areas where the bank overburden was removed (Fig.5)

Erosion control blankets are used to stabilize soils or channels exposed by construction or other disturbances. The blankets hold soil or bed material in place until vegetation or other processes create natural stability.

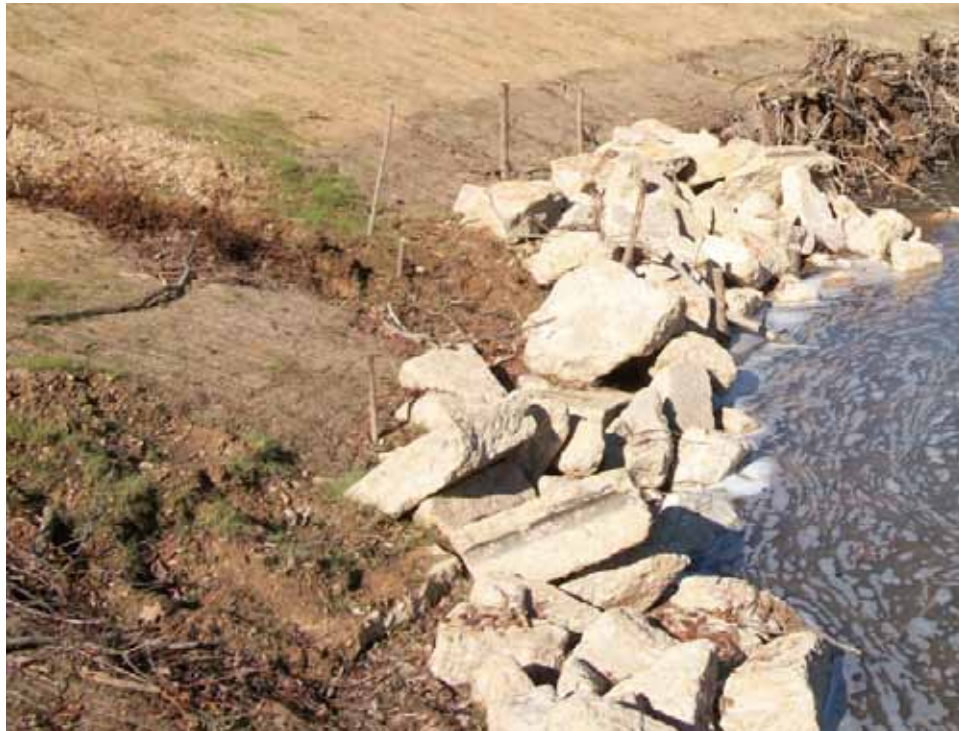
Figure 7. Rock at toe of slope.

broken, debris-free concrete. An additional 600 feet, approximately 300 feet at each end of the BMP reach, was stabilized at the toe of the slope with broken concrete (Fig. 7).

Broken concrete was placed at the toe of the slope to prevent erosion from undercutting the bank (Fig. 7). In addition to the rock at the toe of the slope, trenches were cut perpendicular to the bank to a length of 20 feet. These trenches were filled with rock to a depth of 4 to 5 feet, and backfilled. This technique, known as "tie-backs", help to slow or prevent the movement of erosion up or down stream should a washout occur.

Though not part of the native landscape, rock is sometimes necessary in erodible soils to prevent the river from undercutting the bank, particularly in highly erodible or unconsolidated soils, such as those on the Buttahatchie River.

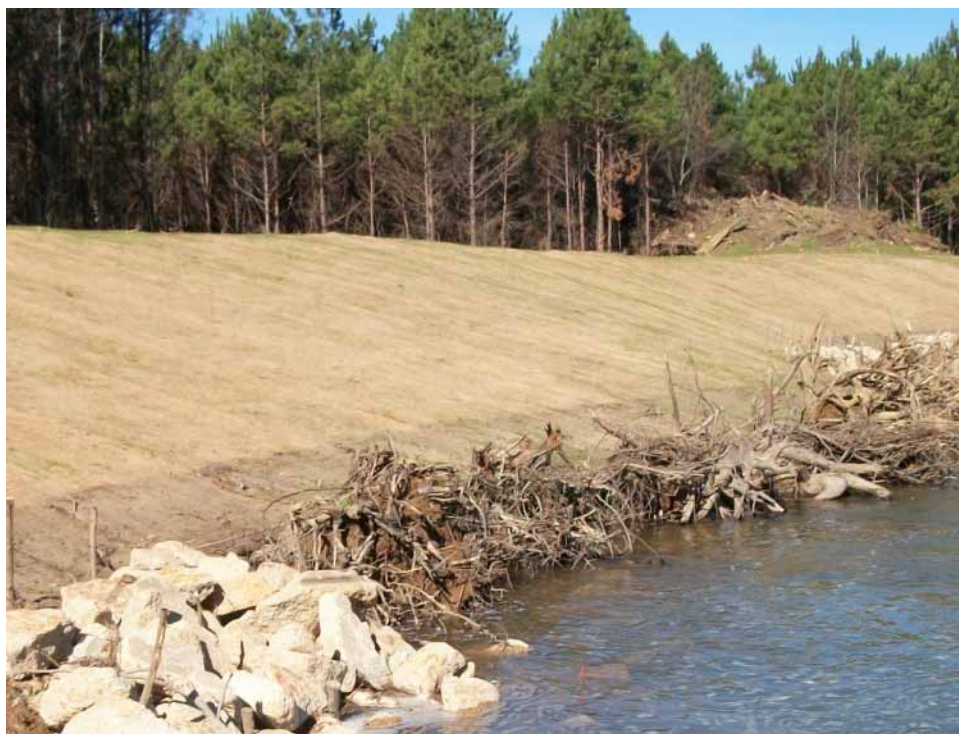
Figure 8. Installed root wads.

On-site hardwood trees were utilized for the root wads. Ten to twelve feet of the trunk was buried into the bank with the roots exposed at the toe of the slope. This prevents erosion and provides excellent habitat. Ten root wads were installed (Fig. 8).

Where the proper trees are available, root wads are an effective stabilization technique.

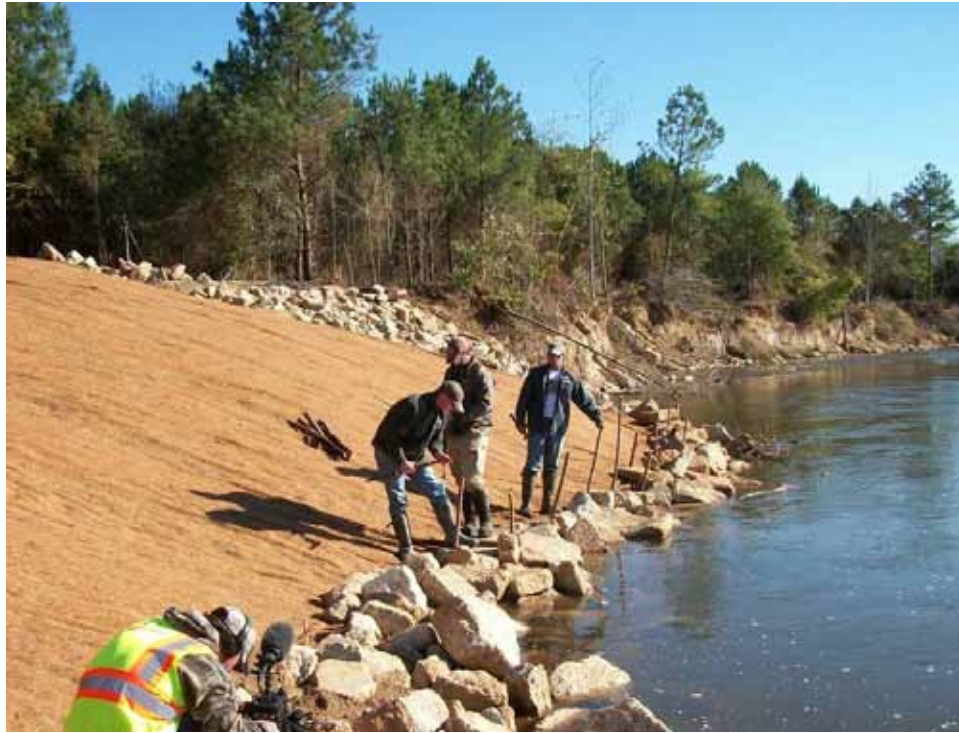
Figure 9. Placement of willow stakes.

Willow cuttings placed into the ground will sprout roots and leaves with the expectation that the roots will spread laterally and grow into mature trees. As they grow and spread, the willows provide habitat and protection from erosion. Willow stakes have been planted along the length of the project on the lower bank, and through the rock placed on the slopes at the ends of the BMP section (Fig 9). At the upstream end of the project, willow cuttings were placed in trenches to form living, flexible "fences" to slow down the water at high flows and reduce erosion (Fig. 10).

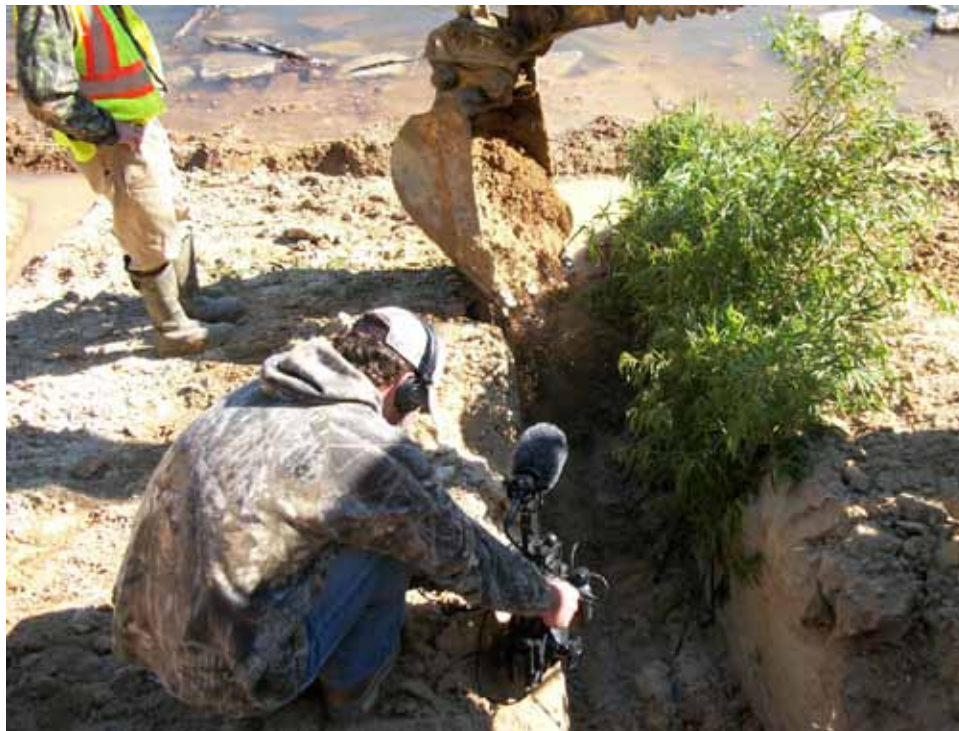
Figure 10. Installation of willow trenches.

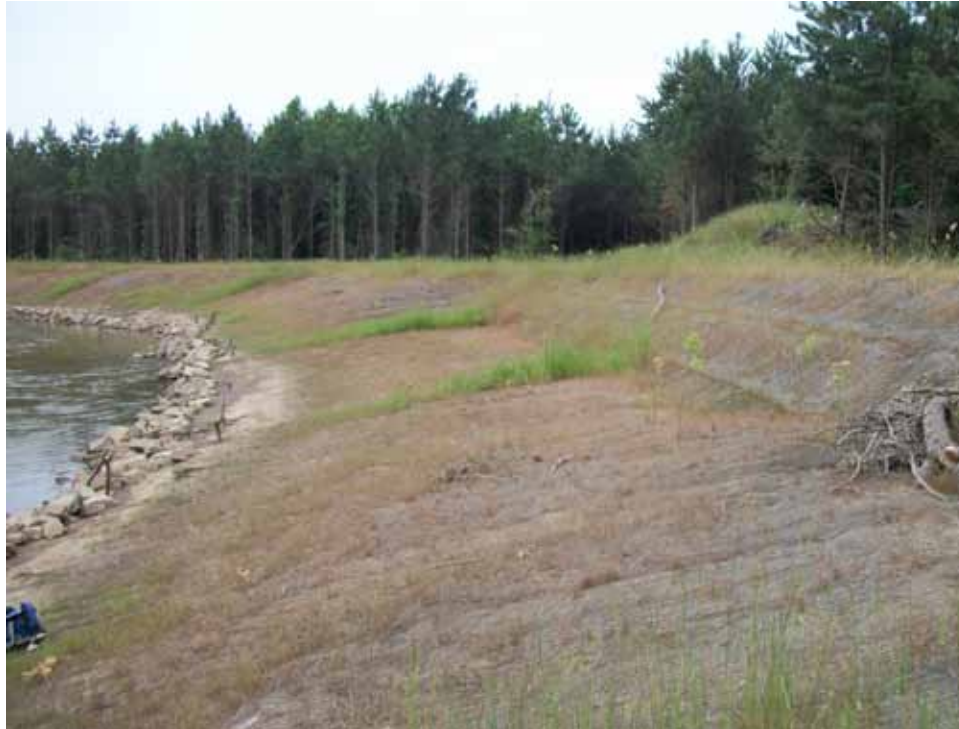
Figure 11. Photograph taken in June, 2011, showing trees and developing vegetation. Note debris deposited by winter floods.

Native trees and other plants have been planted over the length of the project. Planting of native trees and other vegetation is compatible and necessary with all BMPs. As the trees mature, they will provide bank protection, and habitat and food for both terrestrial and aquatic animals. The native plants were planted in two "layers", one of overstory trees and the other of understory shrubs and low trees. The overstory consists largely of oaks, while the understory species include American beautyberry, Chickasaw plums, Pawpaw and other low maintenance plants. Each layer was planted on a 10 x 10 foot grid, with the two grids offset to form an overall grid of 5 x 5 feet. This planting system will establish a high density of roots to better stabilize the soil from erosion. The understory species will reduce pressure on the oaks from animals such as deer and beaver, and will encourage the growth of beneficial soil microorganisms (Fig. 11).

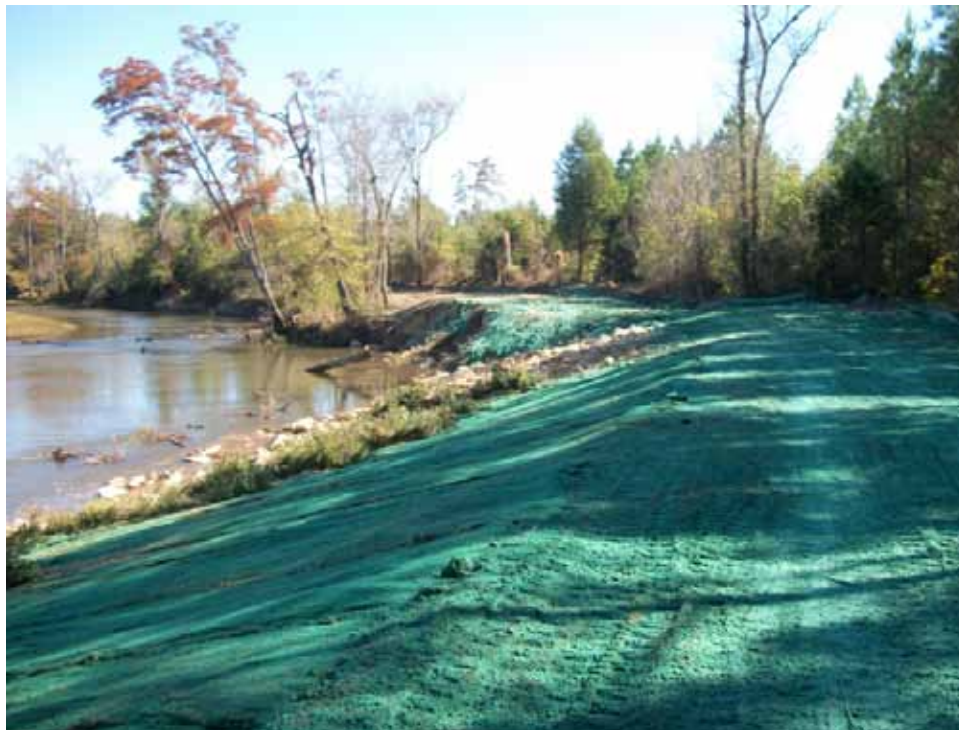
Figure 12. Post-construction site looking upstream.

It has also created an open-air educational site that demonstrates several useful stabilization BMPs and sets of techniques. This unique setting allows for the comparison of various techniques in one location (Figs. 12-13).

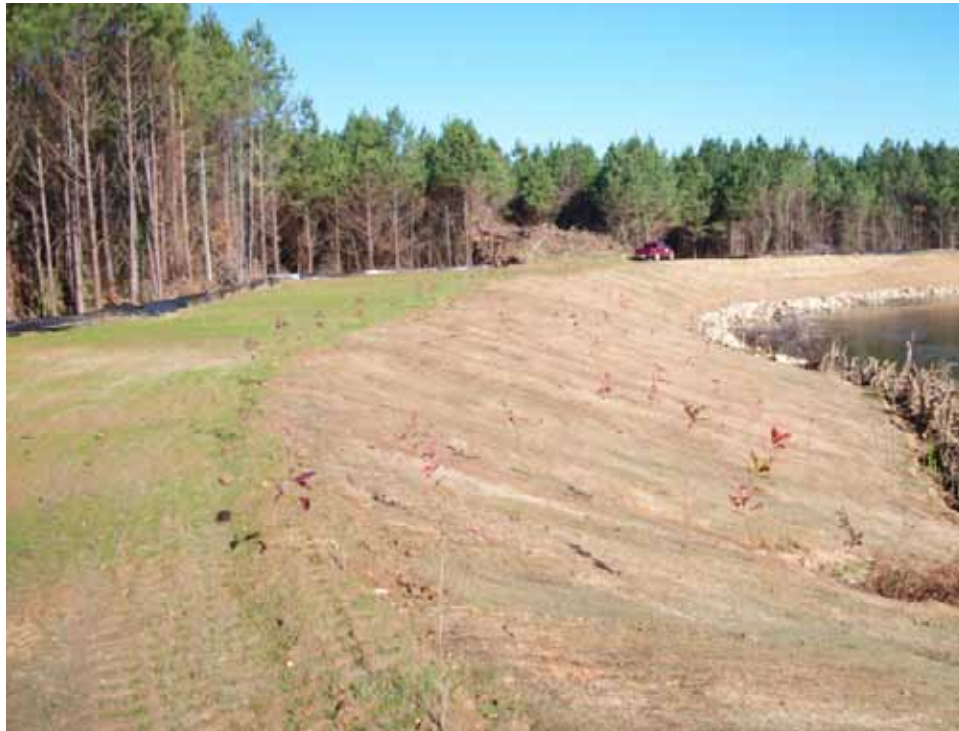
Figure 13 . Post-construction site looking downstream.
