# Identification of Streambank Erosion Processes and Channel Changes in Northeastern Mississippi

Identification of Streambank Erosion Processes and Channel Changes in Northeastern Mississippi  
 Ramirez-Avila, Langendoen, McAnally, Martin, Ortega-Achury, Diaz-Ramirez

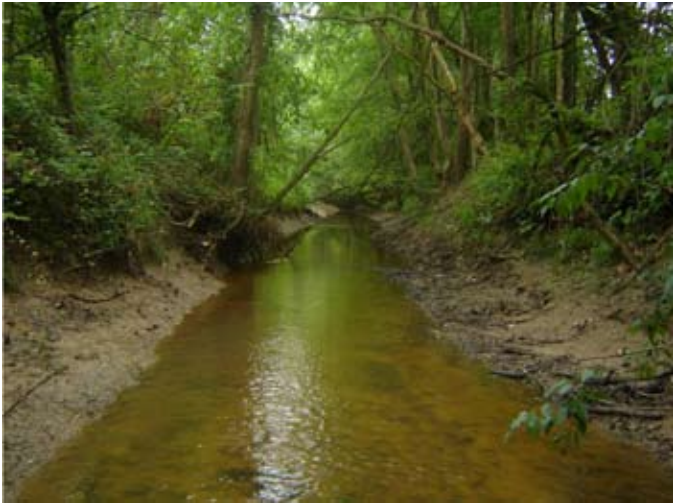
Figure 1. View of a creek at the headwaters of Town Creek, MS

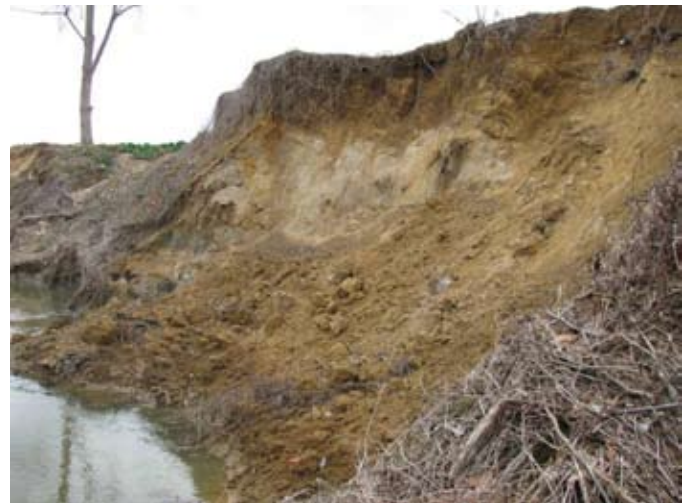
Incised streams with unstable active bank profiles.

Slab failure, soil fall, and cantilever failure, accompanied by a basal clean out process when stormflow events occur.

Figure 3. Incised unstable channel at the Yonaba Creek, MS

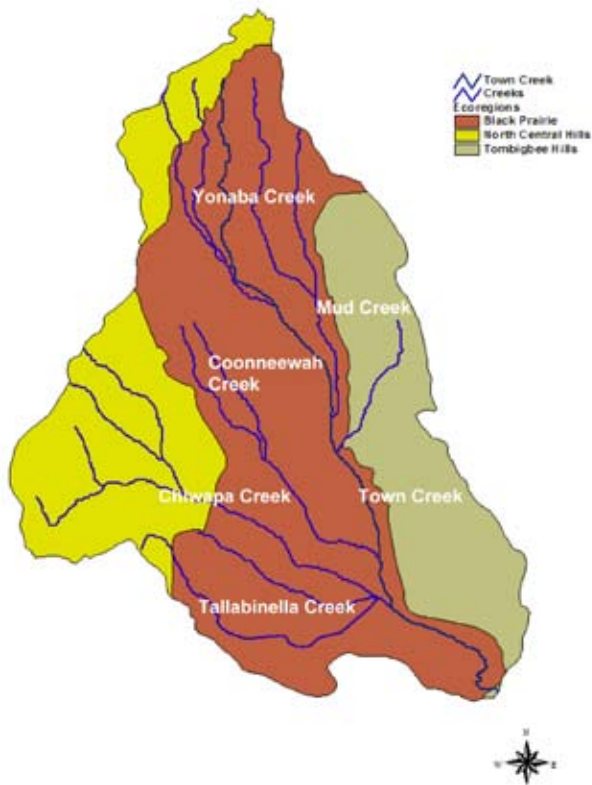
Figure 2. Principal tributaries for Town Creek, MS

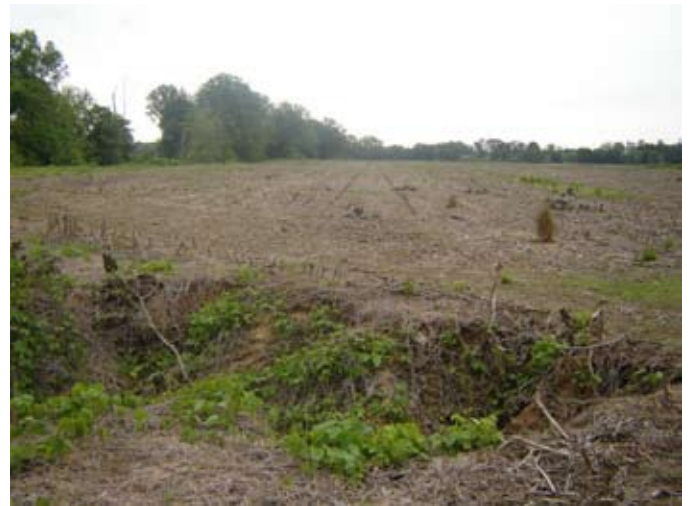
Agricultural land use near streambanks with limited or reduced presence of riparian zones increases streambank instability and favors gully erosion activity.

Figure 4. Gully erosion formation in an agricultural field with reduced presence of riparian zones at the Town Creek headwaters.

The development of a program and implementation plan for streambank and riparian buffer zone restoration and establishment of other BMPs, is necessary to reduce sediment and nutrient concentrations to attain water quality standards within Town Creek watershed.

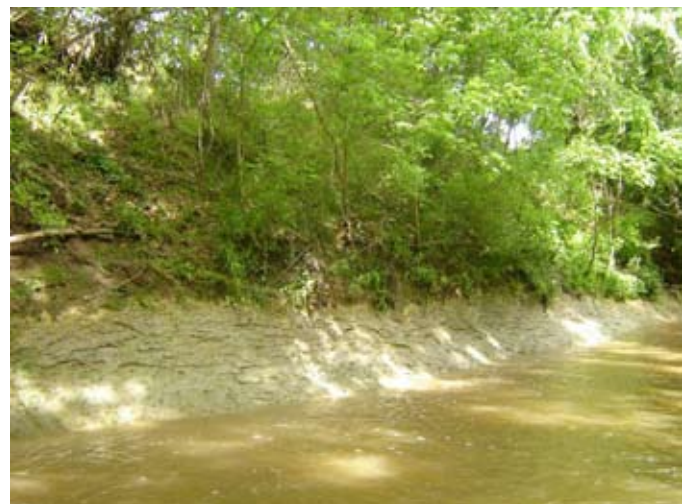
Figure 5. Fluvial erosion at the Town Creek headwaters in MS.

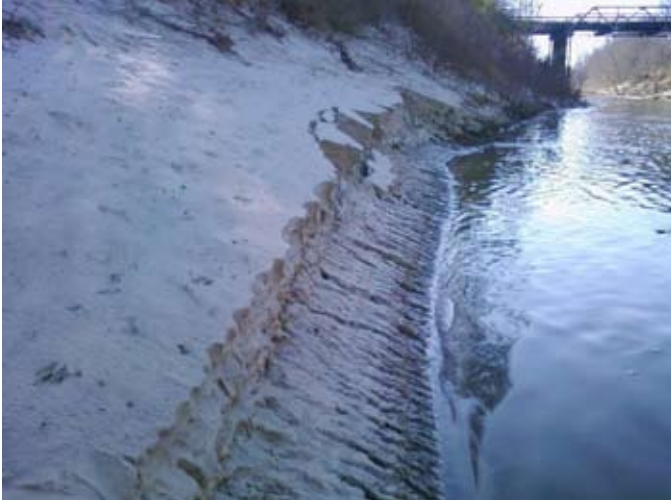
Shallow slides, and rotational failures are mixed with natural, vegetated zones and regions with sediment deposition on bed and streambanks.

Figure 6. Sand deposition on streambanks at the middle section of the Town Creek, MS

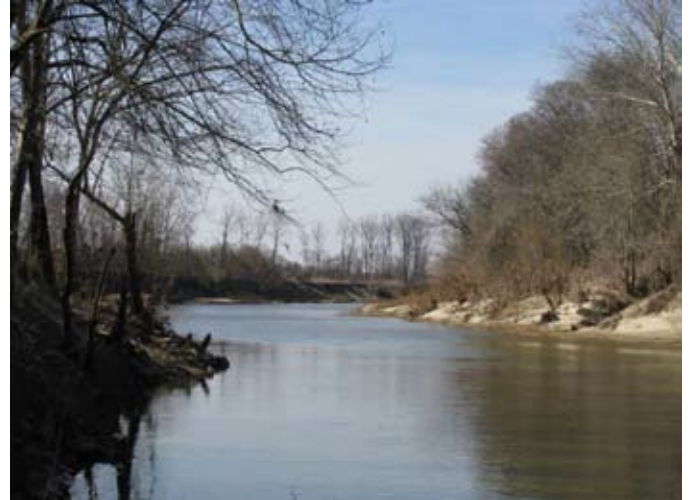
Low flow velocities and sediment deposition occur on the inside of incipient meander bends in the sinuous reach, along the downstream most 10 km before the outlet at the Tombigbee River.

Figure 9. Meandering low flow velocities and streambank sediment deposition at the least 10 km of Town Creek, MS

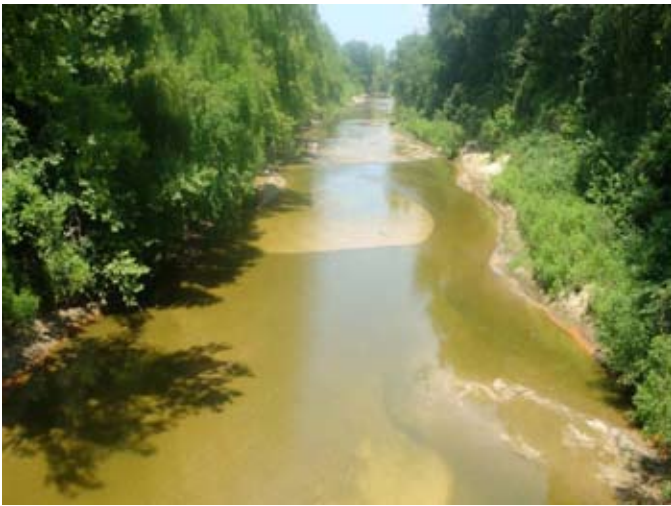
Sediment bed deposition and erosion are significantly modified seasonally by flow conditions.

Figure 7. Mobile ber at the middle section of the Town Creek, MS

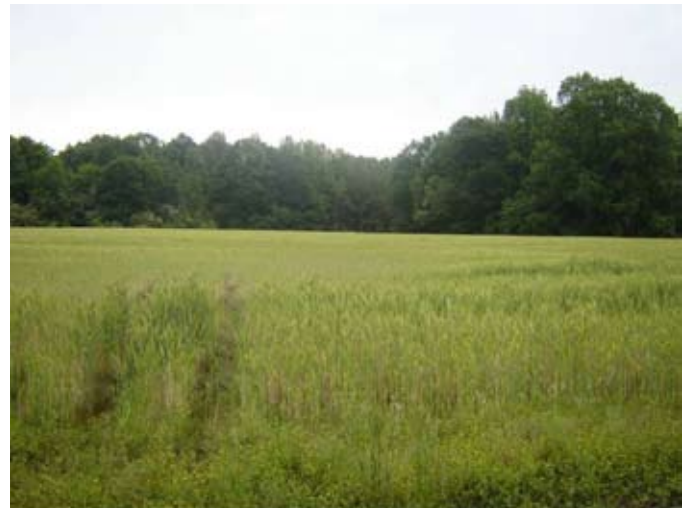
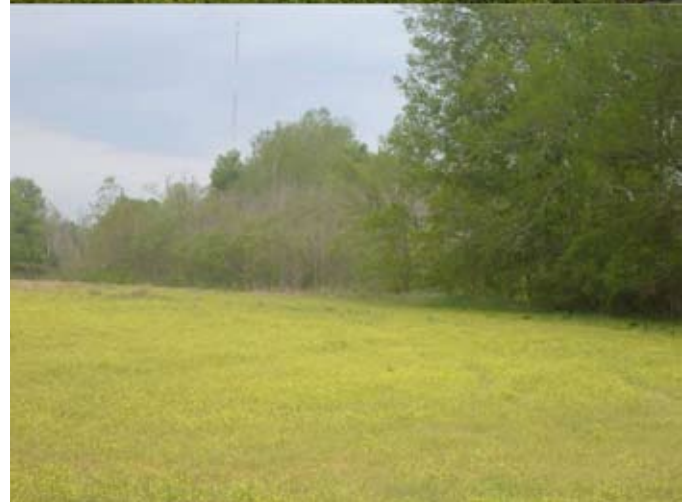
Figure 10. View of agricultural fields with an established riparian zone

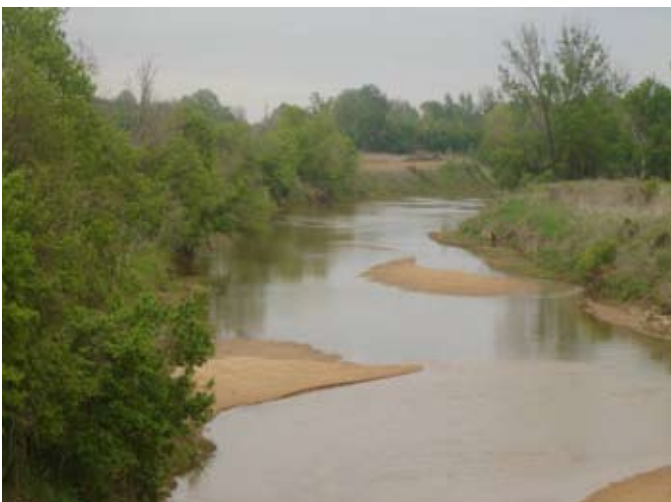
Figure 8. Meandering low flow velocities and bed sediment deposition at the least 10 km of Town Creek, MS
